The paintwork and plaster on Evdir and Kirkgöz Hans by Antalya- and some implications drawn concerning the original appearance of 13th c. Seljuk State buildings

T. M. P. DUGGAN*

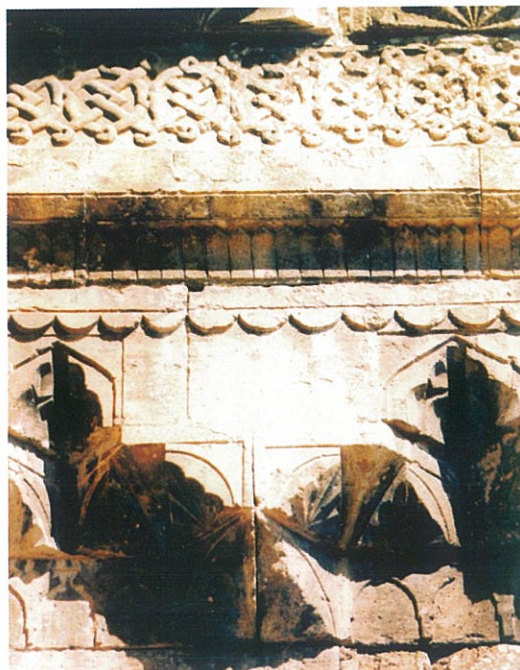
Fig. 3

Further, in some protected inner parts of the carved stonework of the portal of Evdir Han, again largely on the right hand side, there remain *in situ* today (Fig. 3, 2007) traces of a very smooth thin layer of plaster applied to the stonework. This smooth plaster coating extends over areas of the stone carved *muqarnas* above the niche to the right of the door, over areas of the stone frieze-band above and also over areas of the carved interlace band that extends around the interior of this portal below the *muqarnas* semi-dome above the door and this stone carved interlace *torus* band extends to frame the niche of the portal on its outer face. This thin plaster coating over the carved stonework was probably also covered by the thin sealant coating and then painted, perhaps on the plain frieze-band area of the portal carrying a painted inscription or a foliage design¹⁹. That the finely

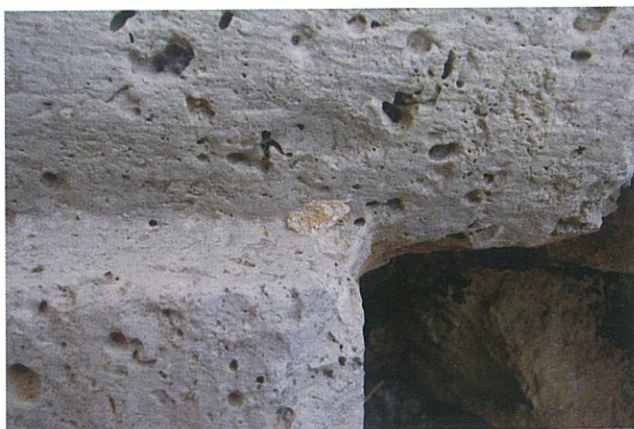
Fig. 4

There is also *in situ* evidence of yellow paintwork upon small areas of plaster that still remain attached to the in-filled joints between the large stone *spolia* blocks forming the exterior wall lying to the right of the portal, suggesting the exterior wall surfaces of this han were originally covered in yellow paint on plaster (Fig. 4, 2007, T. Kahya).

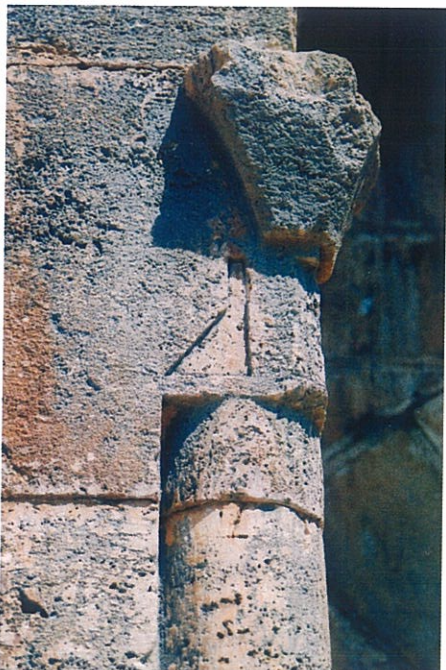
Fig. 5

Like the portal of Evdir Han, and also previously un-mentioned in the literature, there is evidence of a prepared coating that was applied to the carved stonework surface of this entrance portal to receive paintwork, it remains *in situ* today in the recessed carved areas of the capitals on either side of the entrance (Fig. 5, 2007) and on relatively protected areas of

the half columns and on their facing inner sides, as elsewhere upon the carved stone blocks on the outer face of the entrance portal, forming a smoother surface on top of the carved limestone. This coating in places on the columns as elsewhere, still carries traces of the original shiny paintwork applied to this south facing entrance portal (Fig. 6, 2007), paintwork that is largely of an off-white color and also in places there remains some slight traces of red paint work. In 1990 there was still clearly visible on the side of portal the trace remains of the Seljuk red zigzag-chevron design (Fig. 7, 1990) that originally covered the sides of this portal, paintwork now entirely lost. For other examples of this design, see type 4 below.

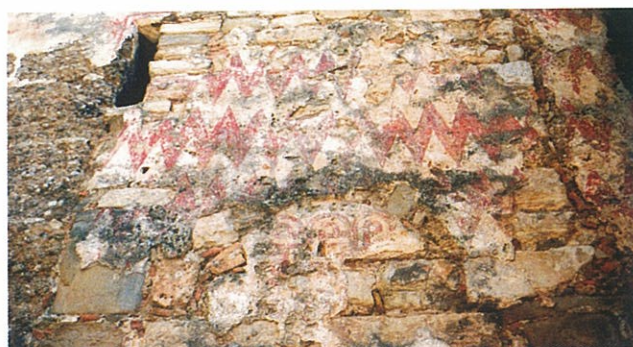
Fig. 22

Middle Ages"⁶⁹, and which possibly matched the incised and then painted in red⁷⁰ Kufic calligraphic remains that are damaged but remain *in situ* today on the north face of the south tower (Fig. 22, 1990). This surviving "heraldic"-calligraphic "emblematic" inscription is located within a white plastered lunette, the border to this lunette was probably formed of cut glazed tile work, given the impressions that remain today in the plaster. A. Aziz in 1932 could report of this palace, "This (the broken Seljuk tiles in the tower rooms) would be a strong indication that the building was once used by the Seljuks *even if there were not script* and suchlike giving particular confirmation, too strong a sign for it to be just coincidence"⁷¹. This reference to script presumably referring to these two examples of painted calligraphy on the north and south facing towers either side of the stage, although there are other references to painted Seljuk calligraphy on walls recorded in 1931⁷², painted calligraphy that no longer survives. Consequently, calligraphic inscriptions were painted on interior plastered walls, as also upon some protected areas of external walls, as the remains of red⁷³ painted freehand Seljuk calligraphy without incised borders, which remains visible on the plaster covered border of the brick arch providing access through the middle wall in the fortifications of Alanya and as a surviving fragment from the palace at Alanya indicate. Calligraphy on the plastered exterior walls of a Seljuk building is also depicted in a miniature in the Konya mid-13th c. Varka and Gulshah manuscript⁷⁴.
