A New Monumental Gate from the Roman Imperial Period on the Attaleia City Walls

BURHAN VARKIVANÇ – İSMAİL AKAN ATILA*

Abstract

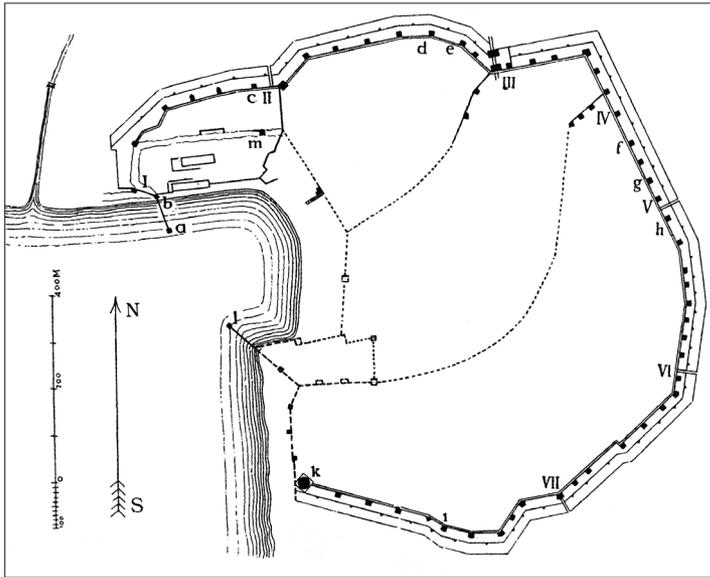
FIG. 1
Attaleia city walls
and gates
(von Lanckoroński
[2005], fig. 4).

the end of the 19th century, K.G. von Lanckoroński provided an extensive depiction of the city along with its towers, reporting seven entrances⁷ to the land fortifications (fig. 1), and introducing this entrance in detail by way of illustrations accompanying his text.⁸ The entrance appears to have been completely closed off in the Early Byzantine period and was not operational for over a millennium. Its central passageway was reopened in early 1880, and the consoles that were held by columns in the original structure were supported with quadrilateral legs (fig. 2).⁹ The structure¹⁰ was revealed for the most part, and its supports conserved during the systematic and extensive destruction which increased due to neglect towards the end of the 19th century and continued until the 1930s.¹¹ It acquired its present-day appearance following excavations and repairs¹² undertaken from 1958 onwards.

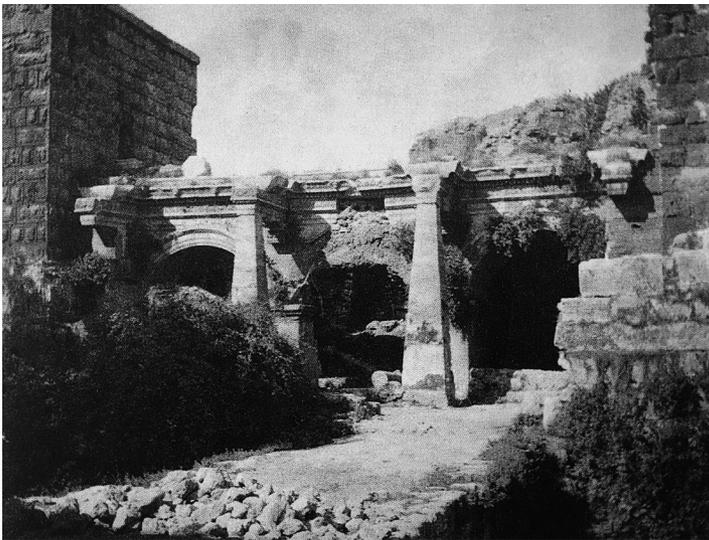
FIG. 2
Hadrian's Gate.
In the year 1882
(Başgelen 2005, fig. 14).

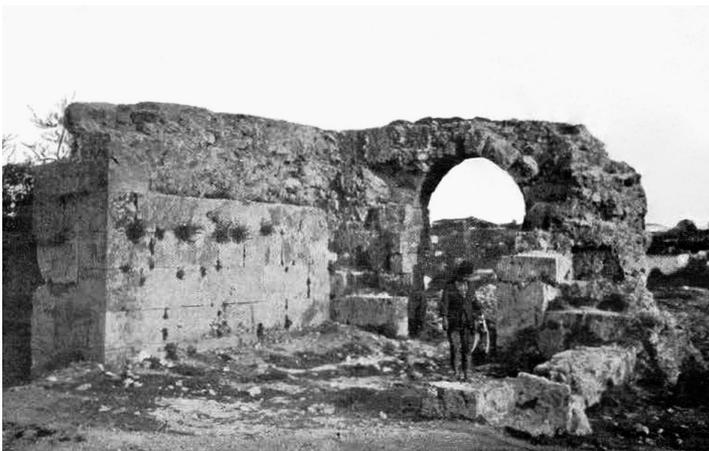
FIG. 3
Tophane Gate
(Pace 1921, fig. 6).

B. Pace, who visited the city during the demolitions that occurred in the early 20th century, noted arched apertures at two additional points on the city walls. One of these is the Tophane Gate in the north of the city, which is also reported by K.G. von Lanckoroński (fig. 3).¹³ This gate was eliminated during the demolition of the walls, and an examination of its walls and arch in the published illustration reveals that it was built during the Antique period. In addition to this gate, B. Pace notes the existence of another structure between Yeni Kapı and Hıdırlık Tower in the south of the city which he describes as “a two arched public building” (fig. 4).¹⁴ Later researchers made identical statements.¹⁵ In the illustration published by B. Pace, a rather large aperture made of fascia blocks is visible. The rubble mass behind it indicates that the aperture, as was the case with the Gate of Hadrian, was probably closed off during the Early Byzantine period. The second arch mentioned by the researchers is not visible because of filling and the destruction. The observable aperture is located between partially destroyed interior and exterior city walls made entirely of spoliated stones. When its position is considered, it is inconceivable that the arched structure belonged to a public building.¹⁶ It is highly likely¹⁷ that the structure is one of the southern entrances to the citadel constructed during the Ancient period.¹⁸

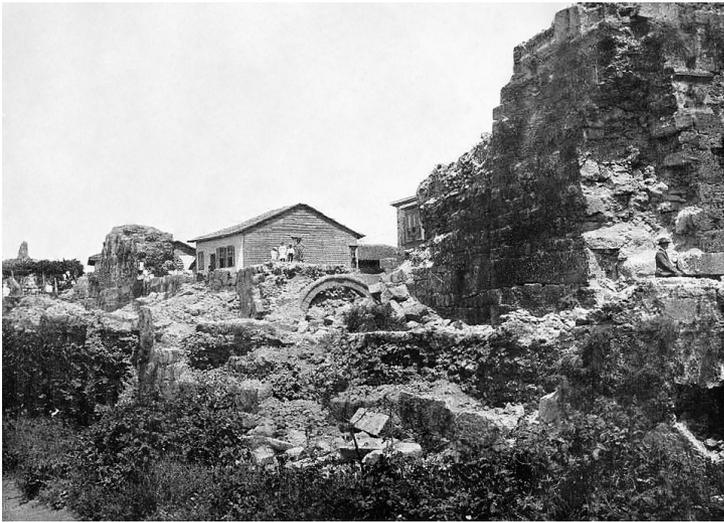
FIG. 4
South Gate
(Pace 1921, fig. 4).

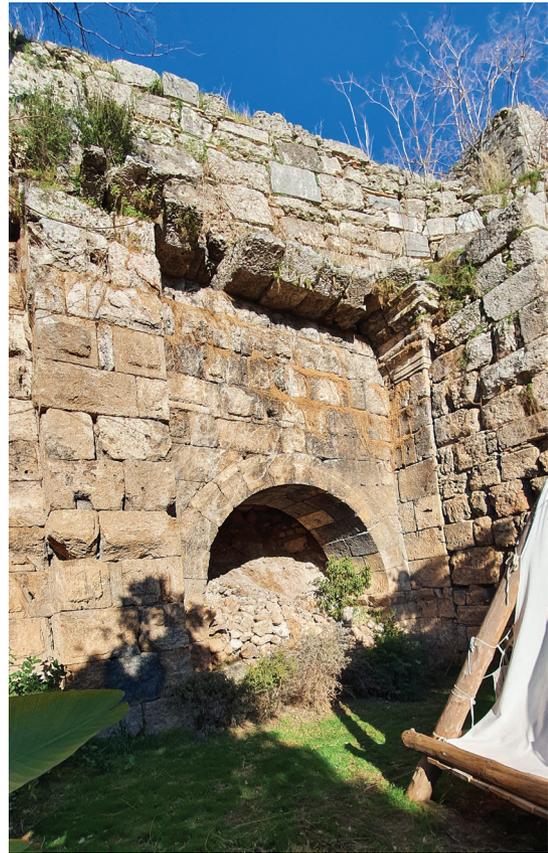
FIG. 9 New City Gate (B. Varkıvaç).

The arched aperture which this study focuses is in the interior shell of the curtain wall that was mentioned and is adjacent to the Early Byzantine period tower structure in the south. Just like the wall and the tower, it is built completely of travertine blocks and is in the form of a half circle (figs. 9-11). Due to the accumulated debris, four rows of blocks can be observed in either direction on the piers which stand 3.85 m apart, and on account of the high fill the gap can be observed about 1.55 m below the beginning of the arch. The total visible height of the aperture is 3.60 m. Based on the clearance between the piers the diameter of the arch (3.80 m) is 0.05 m narrower. The diameter center of the arch, which exceeds a semicircular form, is 0.14 m above the impost bed. The arch rising above the piers sits on the impost bed, which projects by 0.10 m on all directions. The depth of the arch, whose stones are made up of two blocks each, is equal to the thickness of the wall it connects to. The outer borders of the arch block that project by 0.07 m from the wall surface through molding in either side have been cut with a regularity that parallels the curve in the interior. The block widths observed on the façade of the arch including the keystone are quite close (0.50 m). Despite remarkably meticulous workmanship on either side of the interior and exterior façades of the opening, there are pilasters constructed concurrently with the wall and the arch (fig. 12). In the outer pilasters that are revealed due to destruction in the opening, only the sides facing the arch opening are visible. Inside the citadel, only the pilaster in the north has all of its faces exposed, whereas for the one in the south covered by the tower wall added later, only has the face in the direction of the opening is visible (fig. 9). The pilaster with all the faces visible has revealed that they are 1.50 m wide, 0.75 m deep not counting capitals. The total visible height of the pilasters, which feature the same surface workmanship and as the inner wall is 6.10 m.⁴¹ The blocks which preserve their original structures on the two pilasters to the south of the opening, have been fitted with a 1.28-m high entablature in the visible directions of the last three rows (figs. 9, 12-14). This entablature was used on all pilasters as a capital, but it was not preserved in the one located in the north, and these had probably already fallen off before the Early Byzantine period repairs. The blocks, which are quite battered because of the low-quality materials used, feature unadorned profiles (figs. 13, 14). The lower blocks are 0.53 m high and feature three fascias, and they terminate with a crown profile projecting in stages. An S-shaped profile is observed on the top frieze block (height 0.34 m).⁴² The entablature has been crowned with a block 0.41 m high, and in its lower section is a profile of geisipodes, dripstone, Ionic convex kymation, and kyma rekta. It is interesting to note that a capital was not used between the pilaster body and the entablature.⁴³ This implementation gave the structure the appearance of an arch rather than a simple gate. This approach should be considered as the impact of the rich workmanship observed on the façade⁴⁴ of the concurrently constructed Hadrian's Gate, which was possibly undertaken by the same workshop. Consoles that extend along the inner surface of the wall and widen the protected walkway were used on the capitals. These 0.40-m high consoles project from the wall surface by 1 m. These consoles have disappeared to a great extent during repairs on the curtain wall, yet with the exception of one missing block, those located between the pilasters that limit the gate opening have been completely protected in situ (fig. 9).

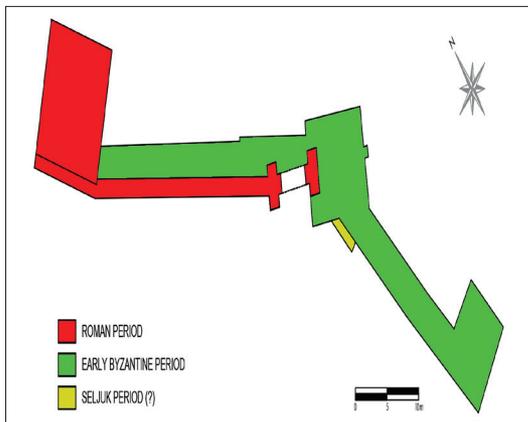
FIG. 8 New City Gate and vicinity (Ş. Güvenç Duran).

A drawing from the survey of the city wall ruins conducted after 1997 revealed another Ancient period city gate built in close proximity to Hadrian's Gate (figs. 8-11). This gate is located in the curtain wall extending from the Iulia Sancta Tower at the south of the Hadrian's

As attested by its inscription,²⁹ the tower the curtain wall connects to in the north was built by philanthropist Iulia Sancta during the period of Hadrian's Gate (figs. 6-8). Today it has two floors,³⁰ and on all façades it has been constructed with travertine blocks with wide framed bossage surfaces.³¹ The northern façade of the tower which is adjacent to Hadrian's Gate has been revealed right down to its Ancient period level while the other façades can be seen from the present-day street level. Past the limestone cornice at the top level of the second floor, the tower is crowned with battlements probably added during the most recent periods of usage (fig. 6).³² Access to the tower has been provided through an arched opening on the west façade. A straight covered opening located on the second floor of the same face leads to the protected walkway on the curtain wall.³³ Another arched opening on the north façade of the second floor opens onto Hadrian's Gate. The two-shelled curtain walls connecting this tower on the southwest corner join the other tower in the south (figs. 6-8) approximately 31.5 m further. Including their battlements, both towers reach a height of approximately 18 m from the original ground level.³⁴ Access to the south tower is provided through the protected walk way mentioned above. The organic connection observed on the outer shell of the wall indicates that the tower and this face of the wall were constructed together (figs. 18-20). The tower,³⁵ which was built entirely with spoliated blocks during the Early Byzantine period, projects from the wall by about 1.30 m on the (outer) east façade. On this side, two long façades (9.50 m in the east, and 9 m in the south) can be observed. The tower has been consolidated with a 1.50-m wide pilaster built in the middle of the wall in the south façade and projecting from the tower wall by 0.40 m. A wide-angle curtain wall extending into this direction is connected to its south corner. The tower is connected to the interior façade of the curtain wall in the north through a right angle and this connection does not involve an organic structure. While the

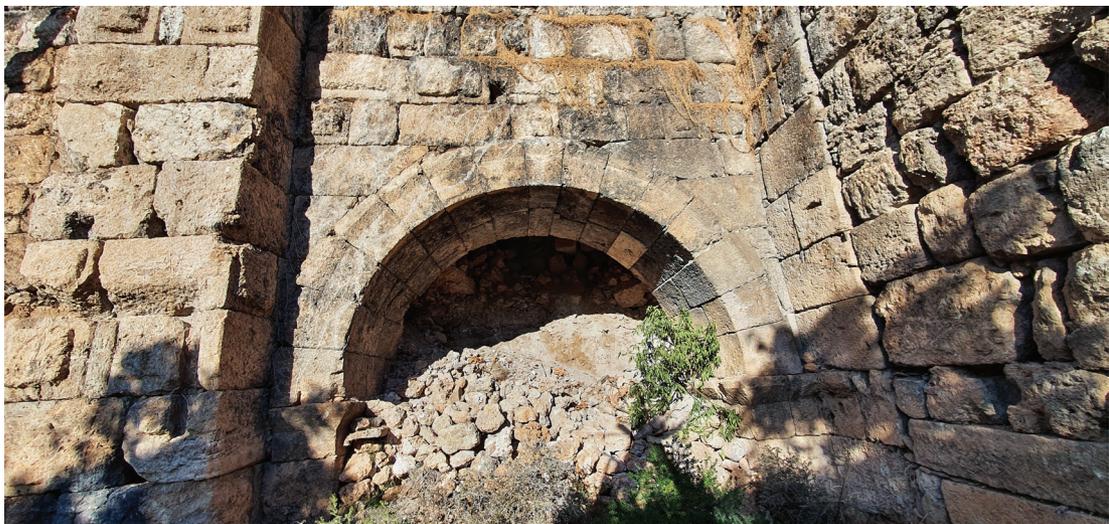
FIG. 10 New City Gate (B. Varkıvaç).

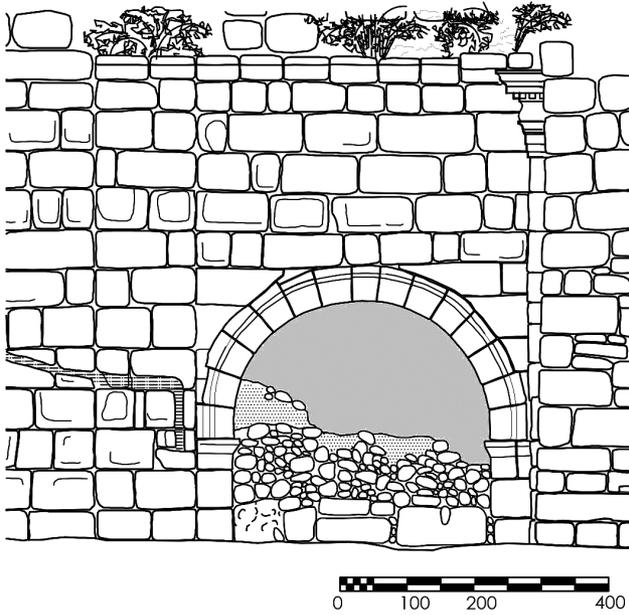
FIG. 11 New City Gate (Ş. Güvenç Duran).

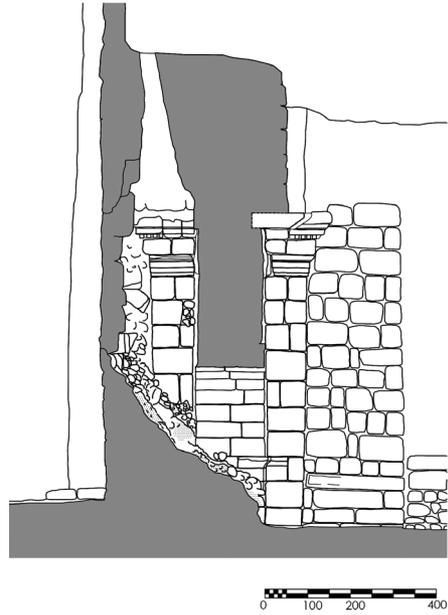
FIG. 12 Cross section of the gate (Ş. Güvenç Duran).

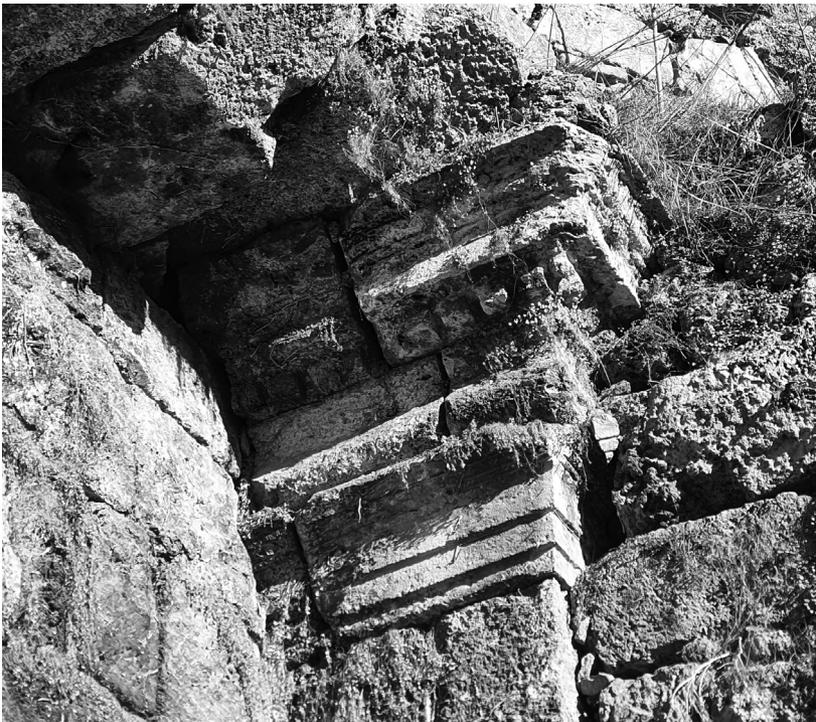
FIG. 13 Pilaster capital (B. Varkıvaç).

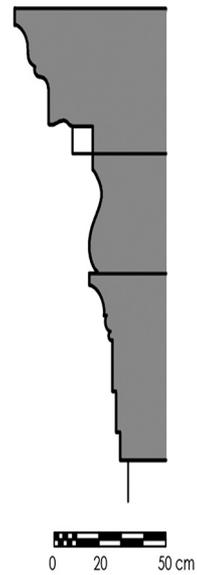
FIG. 14 Pilaster capital (Ş. Güvenç Duran).

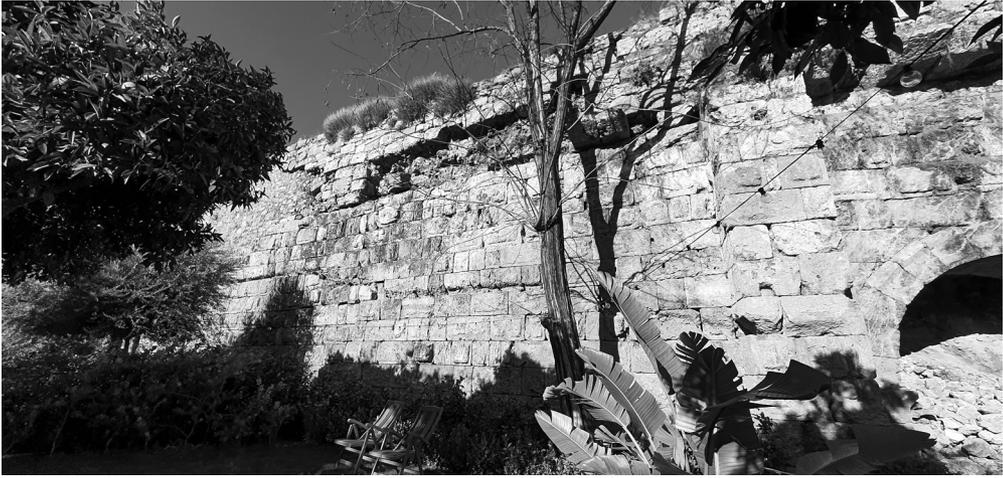
FIG. 15 Curtain wall and Gate. West façade (B. Varkivanç).

The inner shell of the wall features three distinct stone textures (figs. 15-17). The first wall texture features remarkably regular and uninterrupted grout with the exception of some that have been skipped. Starting from the first blocks on the present-day walking ground, the first 12 stone rows of the wall texture can be noted, and the gate discussed in detail below is located in its south edge. After this sequence, extruding consoles are seen on a partially protected row on the gate opening, which indicates a protected walkway (figs. 9, 15).³⁶ The left section of the wall does not feature any of these consoles, but they do continue in the north, in the west façade of Iulia Sancta Tower and the same height. The texture of the wall was created entirely of travertine blocks. The surfaces of the blocks display the same workmanship on either side, and they have been shaped in part by being flattened, and in part with wide framed bossage (figs. 9, 10, 15, 16). The wall directly connects to the Iulia Sancta Tower, which features the same material and workmanship, and this is an indication that the tower and the wall were built at the same time.³⁷ At approximately the middle of the height of the wall surface, there is a recess which starts at the point where it connects to the tower in the north and gradually descends towards south (figs. 15, 16). This recess was meant for the installation of the clay pipes of the water distribution system originating outside of the city, and it terminates

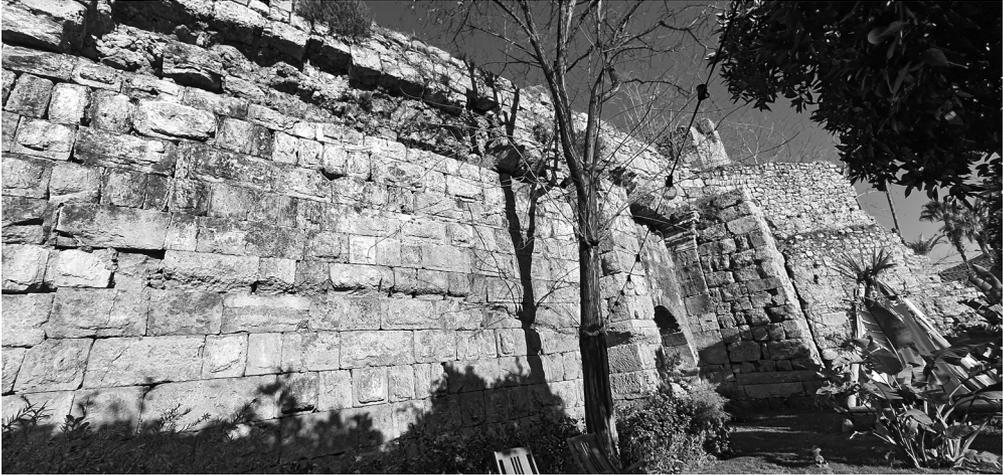
FIG. 16 Curtain wall and Gate. West façade (B. Varkivanç).

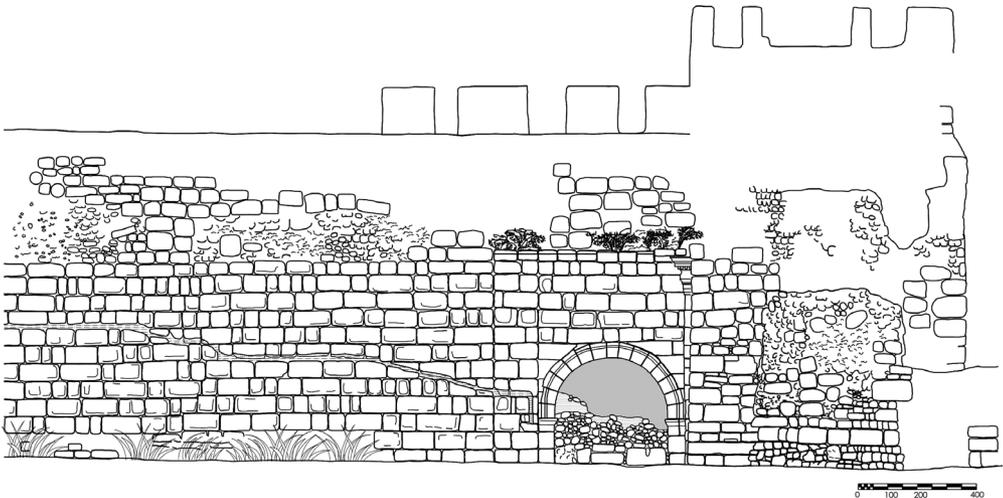
FIG. 17 Curtain wall and Gate. West façade (Ş. Güvenç Duran).

Gate, and is adjacent to the next tower (figs. 6, 8, 17). The main outer wall and the gate which have been studied in detail below were constructed during the Roman Imperial period. During the Early Byzantine period, it was completely closed off with an adjacent outer wall and could not be seen from the outside of the city. Because the inner wall ended up inside private property, in the courtyard of a building in ruins, the gate was not visible until the survey work took place. The first notification and commentary concerning the structure was made in 2008 by researcher C.C. Sönmez. According to Sönmez:

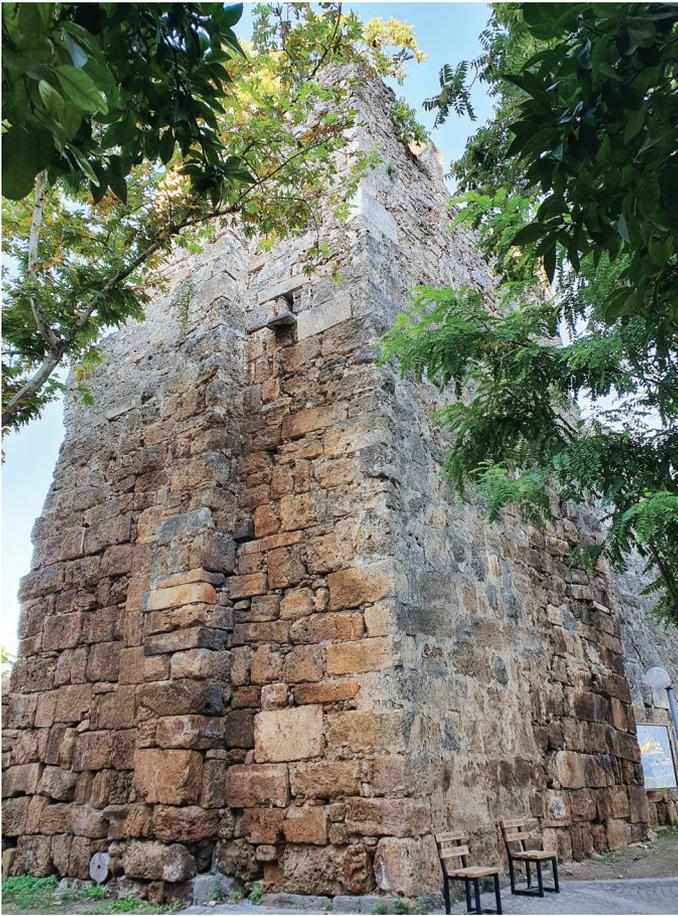
FIG. 18
Tower and curtain wall. East façade
(B. Varkıvanç).

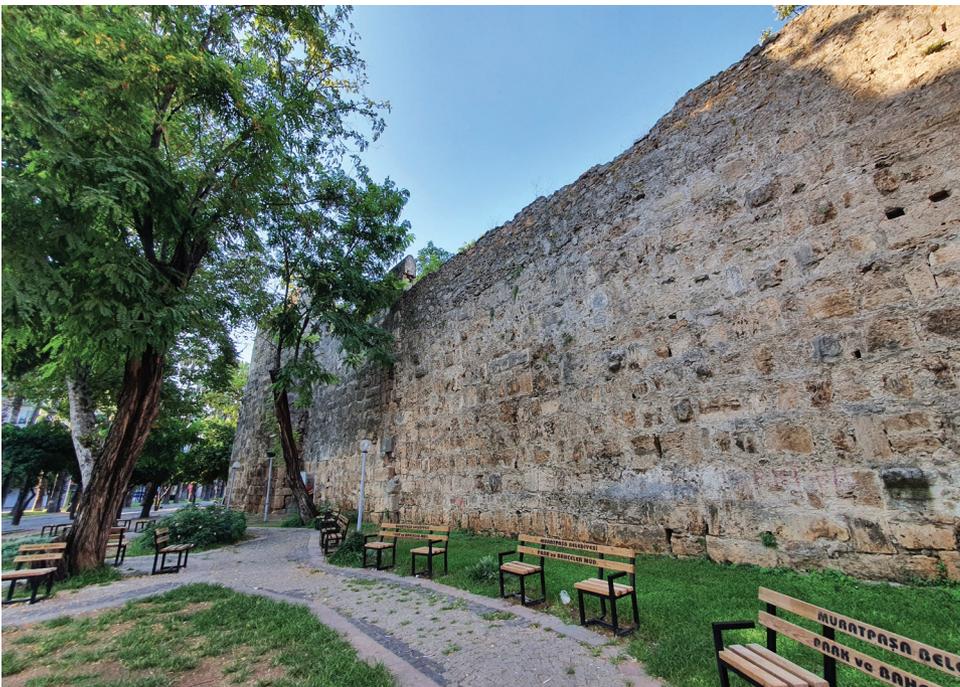
FIG. 19
Curtain wall.
East façade
(B. Varkıvanç).

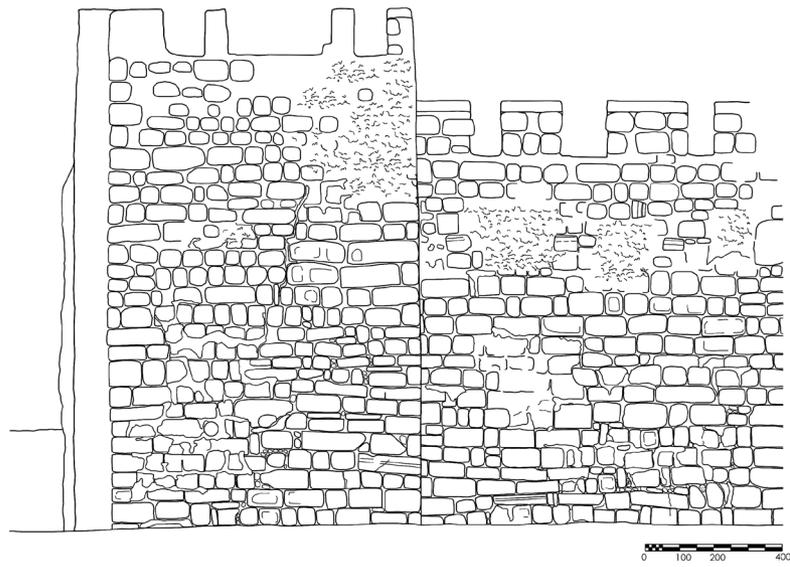
FIG. 20 Tower and curtain wall. East façade (Ş. Güvenç Duran).

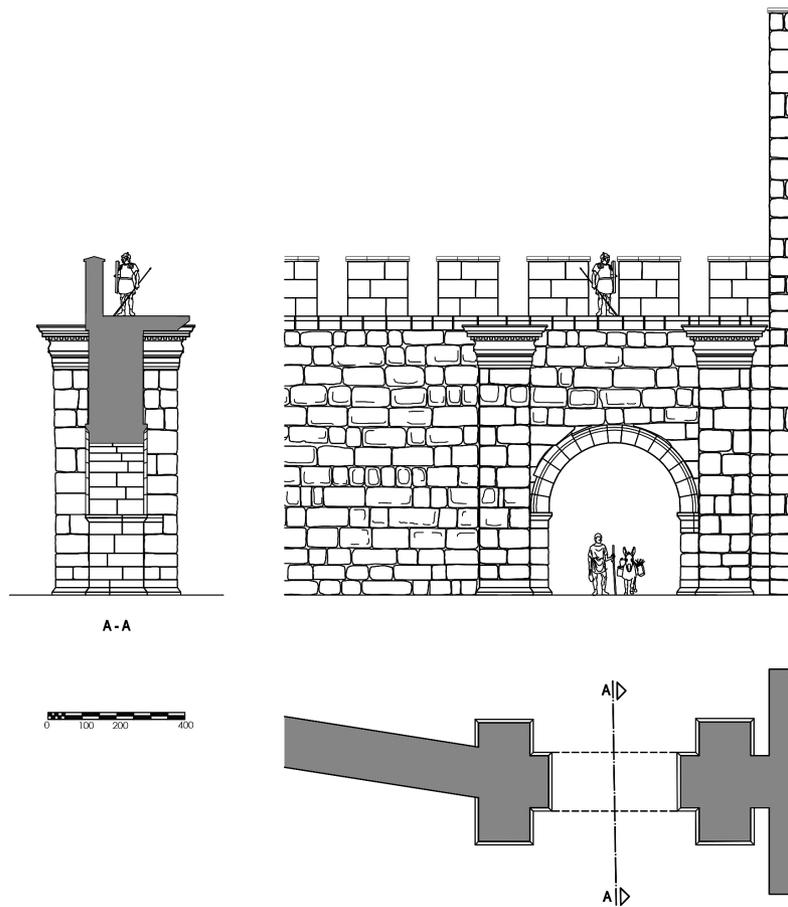
FIG. 21 Restitution of the Gate in the Roman Imperial Period. West façade (Ş. Güvenç Duran).

Due to the high level of the fill, the ground relationship of the arch pier and pilasters cannot be determined next to the gate ground. The projecting impost bed used for access into the arch and the fact that the pilasters have been equipped with capitals possibly indicates that the arch piers and pilasters are not directly set onto the ground and as in Hadrian's Gate,⁴⁵ and that they may possess much simpler gradual bases (fig. 21).
